# NON-DESTRUCTIVE INSPECTION TO EVALUATE WELDING "CASE STUDY"

## Introduction

Non destructive examination has been carried out on some elements of pipe lines and some joints of steel structures that already installed, to evaluate the welded joints and its quality.

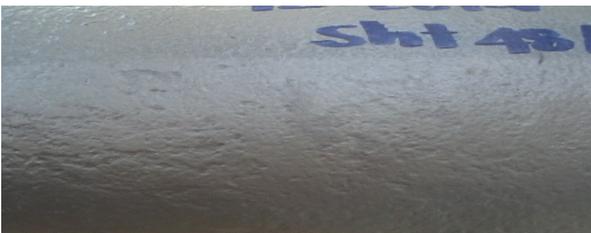
So, in the light of the above mentioned points, it is expected that these dark spots could be nonmetallic inclusions that are present in all steels as a result of steel making practices, which could be oxides, nitrides, sulfides or carbides (2). But at the site and by grinding the surface defects and rechecking using X-ray and UT examination,

the dark spots disappeared completely.

All the investigated films have been accepted, i.e. all the specified pipe surfaces have no defects and have no inclusion. Whereas the dark spots that appeared on the x-ray films were due to the "Pitting corrosion" on the inspected pipe lines and the fittings. And it was found by using UT thickness meter that the reduction on the thickness related to the above mentioned pitting, after grinding, was within the tolerance with reference to the project specifications. So, the dark spots (pitting corrosion) have no severity because they all have been removed by grinding surface. Fig. 1 and Fig. 2.

Fig.1: Pitting surfaces.

- Routine observation should be done periodically (visual inspection, dye penetrant, MT, UT, and RT) in order to avoid any damage or leakage in the future.
- The supplied materials should be checked before receiving and installation to avoid pitting surface due to poor and long storage.

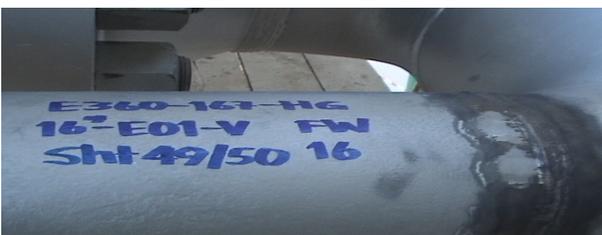
Fig. 2: After removing pitting.

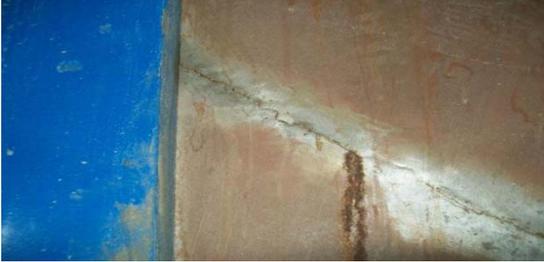
Visual examination checks were carried out on the visible parts of the steel structures. The examination revealed the following external defects (3): weld cracks Fig. 3; lack of fusion Fig. 4; incomplete penetration Fig. 5; porosities Fig. 6; and undercut Fig. 7. Therefore, due to the above mentioned visual defects, it is not necessary to proceed with further investigations using other nondestructive methods.

In light of the previously mentioned defects in the steel structures, we conclude that the welding is not acceptable.

Fig. 3: Weld cracks.

- It is not recommended to work with those defected steel structures.
- Documents should be obtained from the manufacturer (quality and traceability).

–The fabrication of such steel structures should normally be inspected at workshop during fabrication by a qualified inspection body.

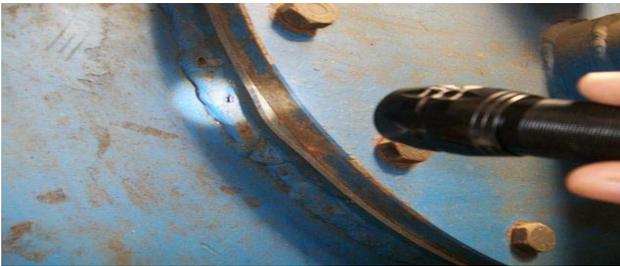
Fig.4: Lack of fusion.

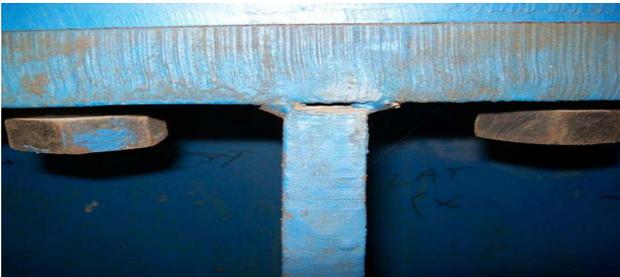
Fig.5: Incomplete penetration.

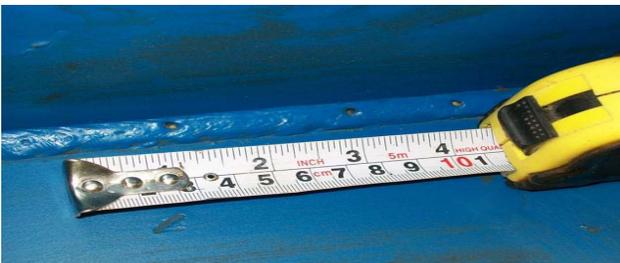
Fig. 6: Porosities.

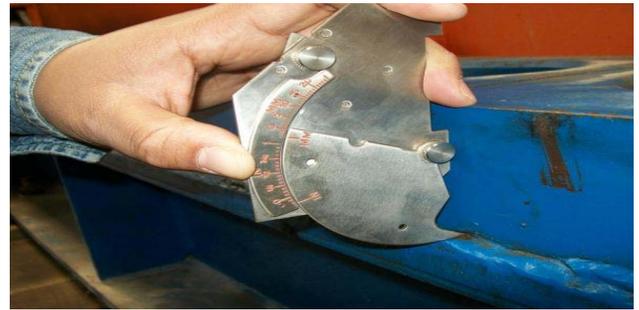
Fig. 7: Undercut.
