# Repair Systems for RC Beam-to-Column Joints with Carbon Fiber Reinforced Polymer under Cyclic Loadings

Uksun Kim, Pinaki R. Chakrabarti, Hector Delgado and Chsung Lam

Department of Civil & Environmental Engineering, California State University, Fullerton, CA 92834, USA

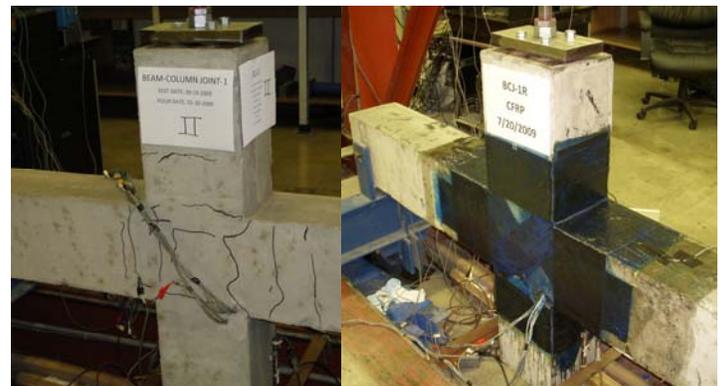
Photo 1 & 2: Beam-Column Joint 1 (BCJ-1 & BCJ-1R)

Two beam-column control joints were tested with the same type of loading sequence, denoted BCJ-1 (Beam-to-Column Joint No. 1) and BCJ-2 (Photos 1 & 3). Both specimens were tested till they showed signs of failure such as; cracking and spalling of concrete, flexural and shear cracks in the beam element. The damaged specimens were subsequently repaired with CFRP and

retested for structural integrity, BCJ-1R (Beam-to-Column Joint No. 1 with CFRP Repair) and BCJ-2R (Photos 2 & 4).

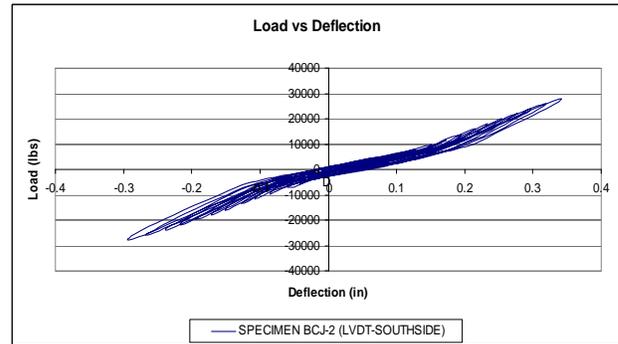
Graph 3: Concrete Beam-Column Joint 2 (BCJ-2)

Specimen BCJ-2 was tested with the idea to stress horizontal rebars to the inelastic range. The test specimen was proceeded with the objective to load it to a maximum of 30 kips of cyclic loading. At the load of 28 kips shear cracks were observed at location throughout the beam portion of the specimen. The testing was stopped to preserve the specimen for the following repair scenario. Repaired specimen BCJ-2R was targeted to reach the loading of 40 kips. During the loading process new flexural cracks was observed at the top of specimen at the load of 18 kips. Shear cracks were observed at the loading of 28 kips. Results of testing are plotted on load vs. deflection as shown in Graphs 3 & 4.

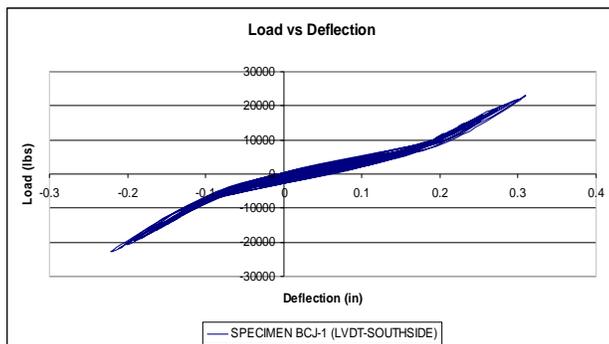
Graph 1: Concrete Beam-Column Joint 1 (BCJ-1)

Specimen BCJ-1 was tested in a load controlled regime. At 18 kips it was found necessary to stop the loading to evaluate the extent of cracks and stresses. It was observed that steel reinforcement was still in the elastic region. Testing was resumed and column loading increase to 23 kips. Repaired specimen BCJ-1R was tested until actuator had reached 36 kips. Visual observation was carefully monitored during the loading process. Due to the CFRP confinement no cracks was able to be observed during the testing. However at near maximum load of the testing cycle, shear cracks appeared on the specimen and therefore the testing was quickly stopped. Results of testing are plotted on load vs. deflection as shown in Graphs 1 & 2.
