# VOLUME CHANGES IN SLAG IN THE SUBSOIL OF CONSTRUCTIONS AND THEIR INFLUENCE ON LOAD-BEARING STRUCTURES

**Radim Cajka, Petr Martinec**

## Introduction

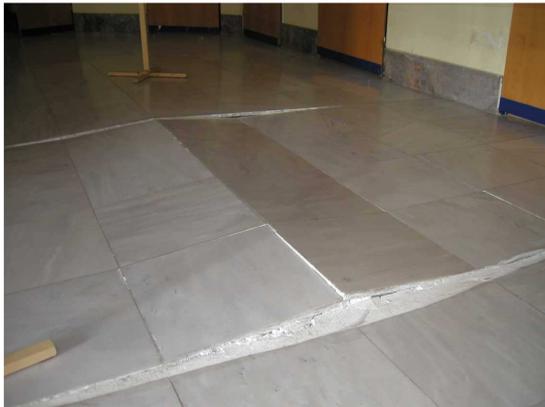
When examining the building in 10/2006, inclined shear cracks in external walls and connecting non-load bearing walls were recorded in the entrance area, public areas, supermarket, storage rooms, and connecting corridors. The door openings and doorframes are distorted and skewed; the floor surface is bulged upward and penetrated by cracks. See Figure 1 for the bulges and the peeled tiles at the entrance area outside the public area facilities (men's and women's restroom, cleaning room). In some places deformations already reach values such that it resulted in the destruction of the brickwork and crumbled parts of perforated bricks, see Figure 2 [1].

Figure 1: Deformation of the floor and tiles

The measurement results clearly show that there is no subsidence of pile foundations present, but the upward bulging of floor structures is present. The upward deformation of some columns is even measured (negative subsidence).

The maximum bulge of the floor reached the value of 39.6 mm within the period of January 23, 2002 to January 24, 2007, and then the value of even 46.1 mm within next 15 months to April 24, 2008 (maximum increase of 6.5 mm in 15 months). However, the initial deformations of approximately 110 mm need to be added to this value, so the last height unevenness of the floor reached over 150 mm as of the date of the last measurement, and the deformations are still continuing. The ongoing deformations are probably related to another reaction with water or water vapor, which could be fed into the subsoil primarily in the form of rainwater infiltration, but also secondarily through a damaged horizontal water and sewer system due to the ongoing subsoil deformations [1].

With regard to these findings it can be stated that the floor structures, non-load bearing brick walls, but also the load-bearing structures of the mounted frame are in disrepair, and with regard to security it is necessary to stop use of the mentioned areas. To be able to reliably use the entrance building in the future it is necessary to prevent volume changes in slag sub-base and sewage leaks into the ground. Given the findings, it is unrealistic to stabilize the slag swelling and prevent further increase of deformations. Also, damaged sewer pipes cannot be fixed without their removal. Manifestations of the volume-involatile steel slag in the embankments were also recorded in the construction of roads [3].

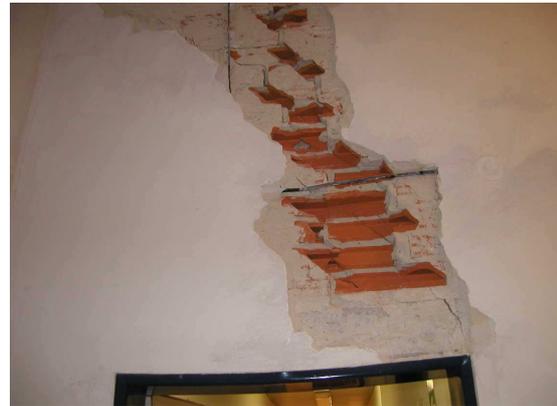
Figure 2: View of damaged brickwork of the non-load bearing wall
