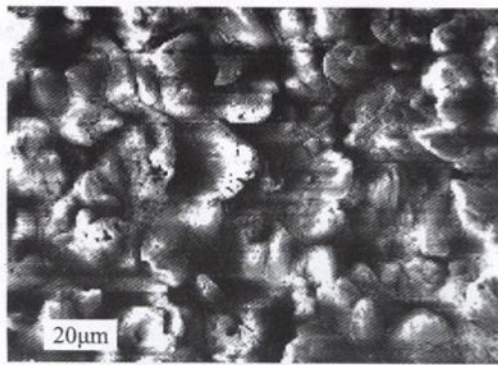
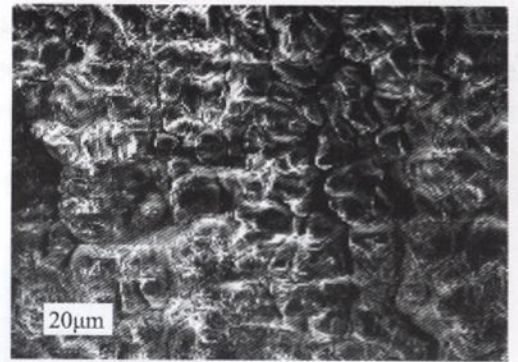
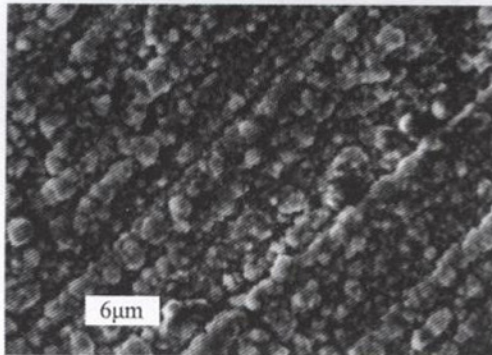
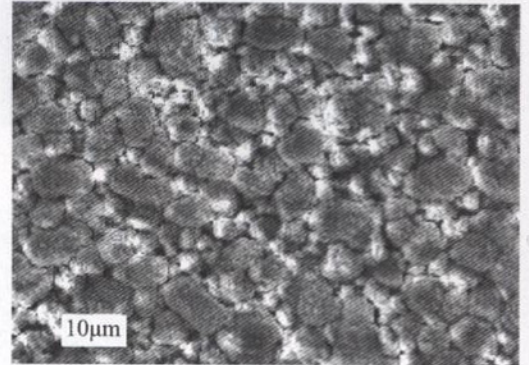
Fig. 4. Surface morphology of steel 430 at 900°C (a) and 1000°C (b) as well as ITM14 at 900°C (c) and 1000°C (d) after 24h of exposure.

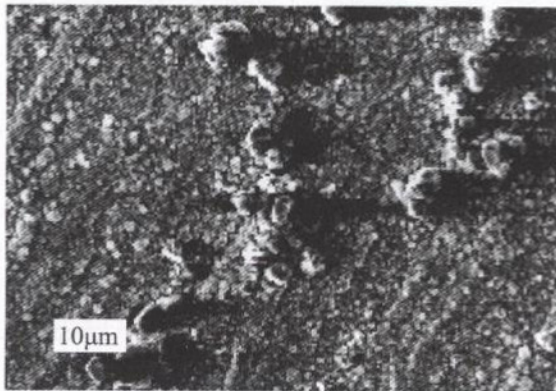
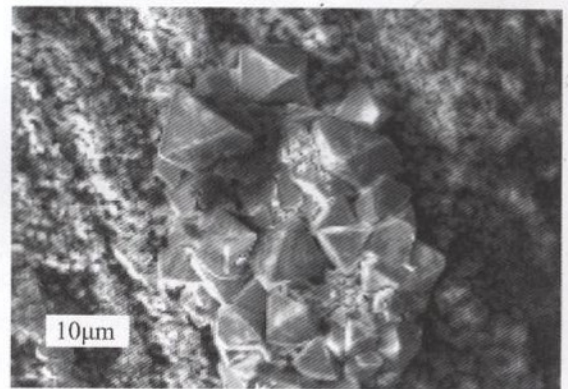
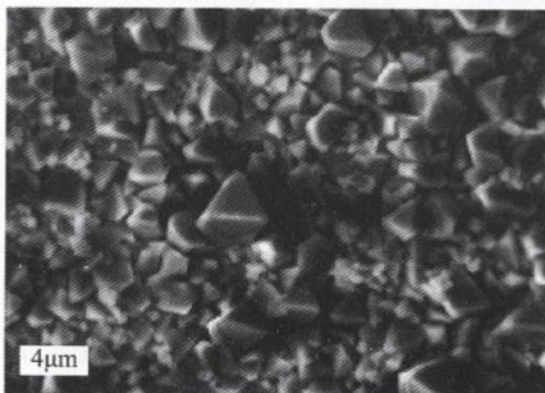
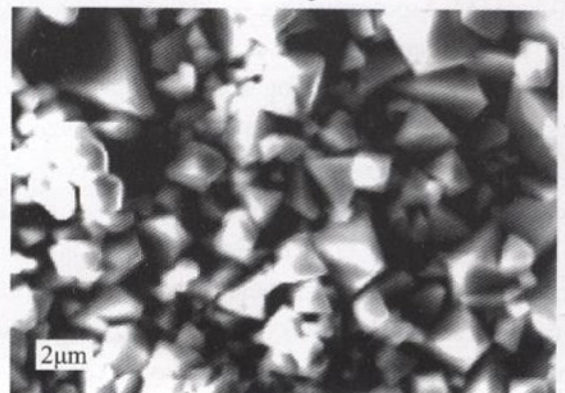
Fig. 5. Surface morphology of Crofer 22APU at 900°C (a) and 1000°C (b) as well as ZMG232 at 900°C (c) and 1000°C (d) after 24 h exposure.
