# REPORT ON HIGH VOLUME FRACTION MMC VIA CENTRIFUGAL CASTING

Eck Industries, Inc., 1602 N. 8<sup>th</sup> St., Manitowoc, WI 54220

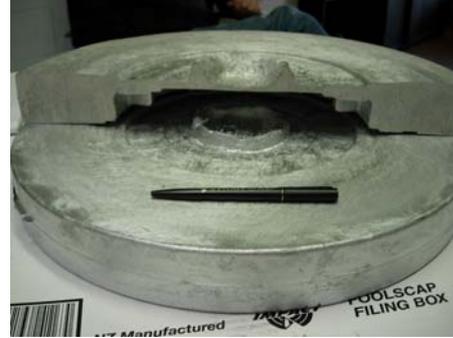
A semi-automatic casting machine designed to make aluminum castings was set up with the tooling for a 450 mm truck rotor. Samples were poured from 6061 material to insure working order of the machine and to assess preliminary settings for best casting quality. The rotors all showed hot tearing at the transition from thick to thin section.

**Figure 1 Rotor Showing Section Differences (6061 Material)**

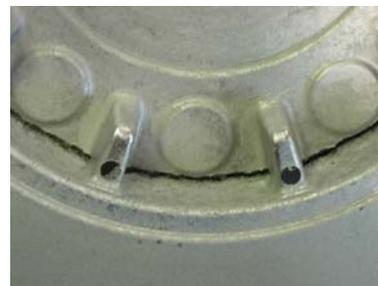
All rotors produced showed extensive hot tearing.

**Figure 3 Composite Rotor Showing Hot Tearing**

The gating was modified on the rotor tooling to determine whether the hot tear could be fed. Hot tears persisted under a wide range of operating parameters.

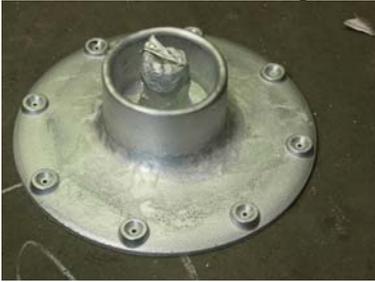
A casting currently produced by centrifugal casting was poured from composite material. The casting was chosen since the geometry was not prone to hot tearing and had been successfully produced in standard alloys.

A number of castings were made so the effect of RPM on distribution of the composite could be determined.

**Figure 4 Sample Castings Poured From Composite**

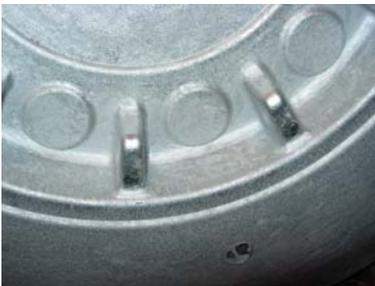
Rotors were poured with 359 20% SiC material modified by the addition of Si to a level of 12.5%. Those rotors poured did not exhibit hot tearing and were sent out for machining and testing.

**Figure 6 Rotor with Modified Si Content Showing No Hot Tearing**
