## BASALT COMPOSITES – INTERNAL STRUCTURE INVESTIGATION

### Abstract

In this paper, analysis of the internal structure of basalt textile composites is provided. Woven and knitted basalt fabrics were saturated with resin Lukosil M130, further were composed together and pressed at 200 ° degrees Celsius. Effect of adding knitted layers between woven layers on the volume fraction of composite components and impact on the inflow and leakage of composite resin have been investigated.

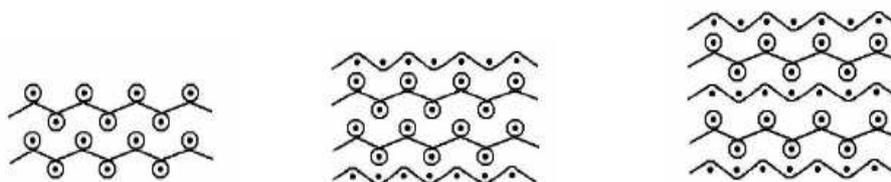
**Figure 2.1** Layer setting - a.) knitted / knitted, b) woven / knitted / knitted / woven, c) woven / knitted / woven / knitted / woven

Six types of composite plates was made by prepreg technology. Each layer were impregnated with resin Lukosil M 130 and layer were dried for four hours at room temperature. Lamination between two metal plates and pressing in oven at 200 degrees Celsius during six hours followed. According to the following schema lamination were provided, see Fig. 2.1 [3]:

Sample no.1 – knitted/knitted on rows

Sample no.2 – knitted/knitted on columns

Sample no.3 – woven/knitted/knitted/woven on warp and columns

Sample no.4 – woven/knitted/knitted/woven on weft and rows

Sample no.5 – woven/knitted/woven/knitted/woven on warp and columns

Sample no.6 – woven/knitted/woven/knitted/woven on weft and rows

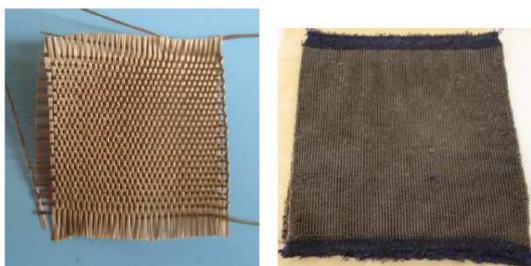
**Figure 2.2** Types of reinforcement - a.) Basalt fabric, b.) Basalt jersey

Basalt fabric in the form of roving in plain weave 1:1 was used, fineness of yarn 1000 dtex, warp texture 160 yarns/100 mm, weft texture 70 yarns/100mm, thickness 0,286 mm, area weight 0.270 kg / m<sup>2</sup>. Basalt weft-knitted fabric with double-jersey was used, column density 40/100mm and row density 50/100mm.

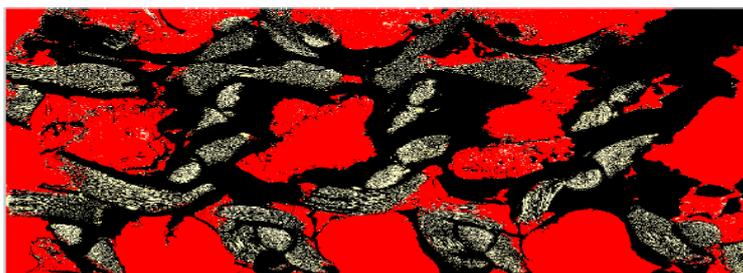
**Figure 2.4** Thresholding image matrix

Microphotographs of internal structure were created. There were used polarized light microscope and scanning compose image technique. Each sample was scanned three times, the total number of pictures was eighteen, which represents approximately 100 hours of work. Images were processed by tools of image analysis (see Fig. 2.4) to obtain structural elements contour -reinforcement, matrix and voids. Furthermore, different types of structural imperfections were observed, see below.

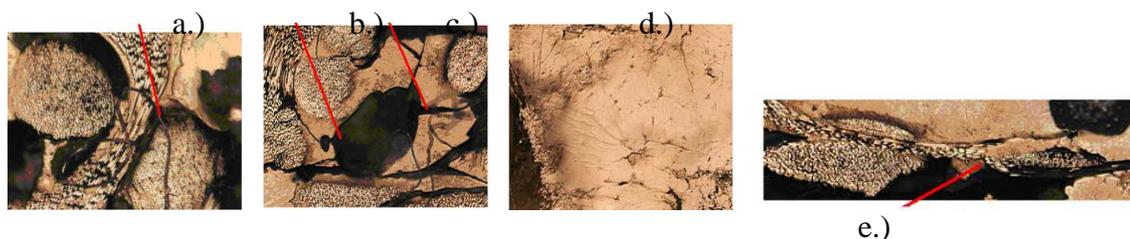
**Figure 2.5** Structure imperfections – a.) rip out fiber , b.) voids, c.) crack, d.) shrinkage matrix, e.) fiber failure

Imperfections were studied from the macro level structure point of view, further work will be examined images from micro and meso structural levels. Imperfections on Fig. 2.5 were found after reconnaissance.

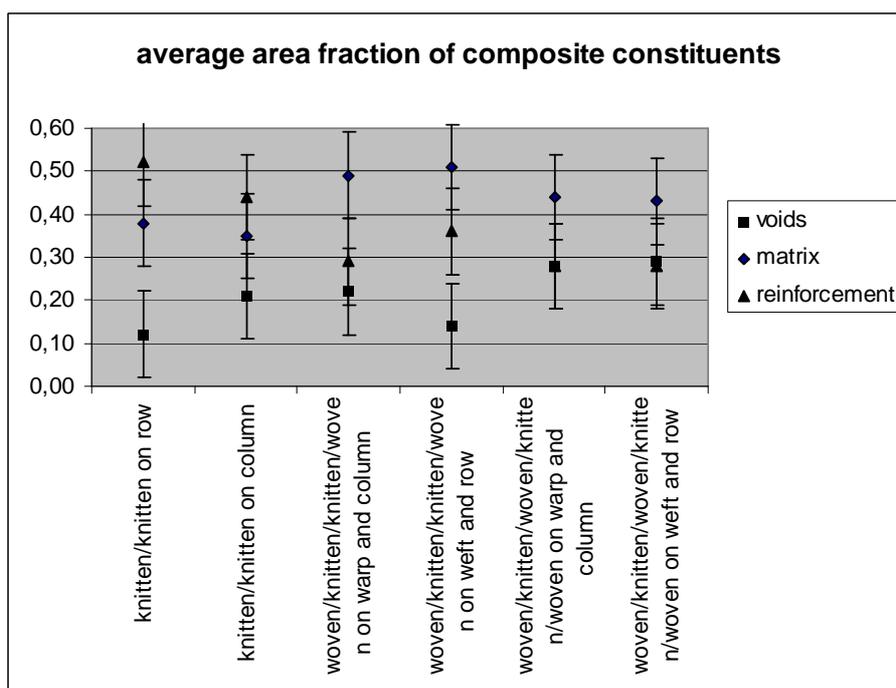
Figure 2.6 Measurement results

Fig. 2.6 represents average area fraction of individual components - voids, matrix, reinforcement. There is show that the largest percentage of reinforcement was found in the type of composite No. 1 and No. 2. This is due to the type of composite, which is composed from two knitted fabrics. This result can be expected because the knitted fabric isn't compressed between woven layers. That is due to its freer structure and more space in structure, which knitted occupies in a cross-section. This fact corresponds to samples No.5 and No.6, which have the lowest percentage of reinforcement. It is apparent downward trend in species No. 1 and No. 3, which may be caused by way of setting (warp - columns, weft - row). Throughout the experiment, beyond the value of the type No 4. These values are probably due to unspecified phenomenon in the manufacture of fabric or manufacture of composite, such as for example grouping multiple fibers in cross-section. One reason may be a random place with a low concentration of voids in the composite. The proportion of matrix increased by adding fabric to knitting, especially for species which have only the outside layers of fabric. This fact is due to better enclosure of resin between knitted fabrics. Types No. 5 and No. 6 have lower proportion of matrix, which may be according to fact, that the middle layer of woven fabric separates two knitted fabrics. Resin extrusion is after-effect.

Area fraction of voids could be grow with advance fabric layer. According to fact that knitted fabrics are flexible, during molding process it will be pushed more air than by using only woven fabric. Woven fabric holds more air, as seen in the type of No. 5 and No. 6 .

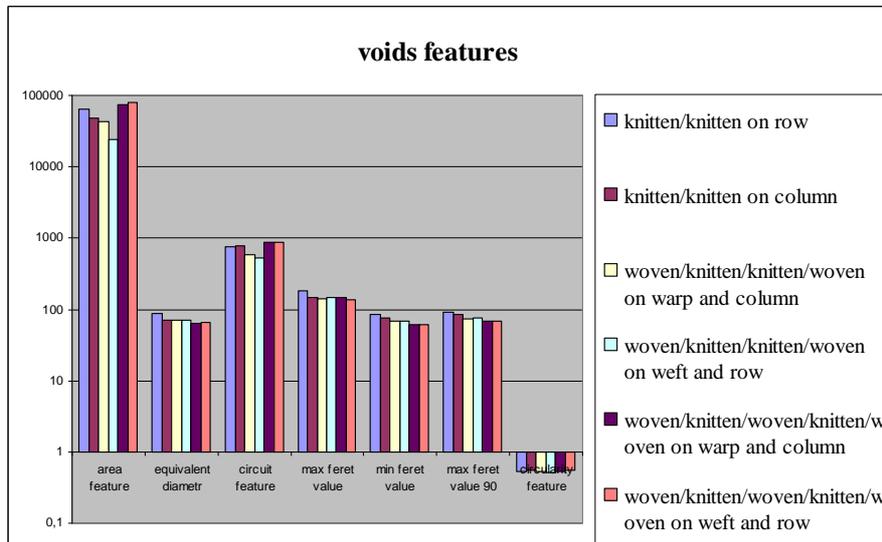
Figure 2.7 Measurement results

Measured characteristics on Figure 2.7 show that the voids occupy the highest area of composite sample No. 6, the lowest on sample No.4, highest equivalent has sample No.1, the lowest sample No. 5, the highest circuit has sample No. 6 and the lowest sample No. 4, max Feret is the highest sample No.1 and the lowest for sample No.6, min Feret is the highest for sample No.1 and the lowest for sample No.6, max feret 90 is the highest on sample No.1 and the lowest for sample No. 6, circularity is the the highest for sample No.1 and the lowest for sample No. 2

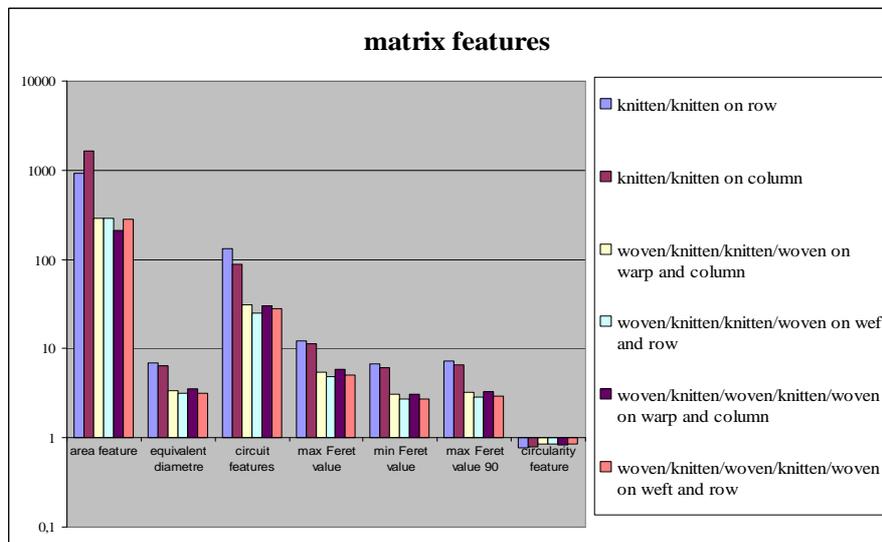
Figure 2.8 Measurement results

Measured characteristics on Figure 2.8 show that the matrix occupies the highest area of composite sample No. 2, the lowest on sample No.5, highest equivalent has sample No.1, the lowest sample No.4, the highest circuit has sample No.1 and the lowest sample No.4, max Feret is the highest sample No.1 and the lowest for sample No.4, min Feret is the highest for sample No.1 and the lowest for sample No.4, max feret 90 is the highest on sample No.1 and the lowest for sample No.4, circularity is the the highest for sample No.1 and the lowest for sample No.3.
