# EXPERIMENTAL ANALYSES ON IMPACT-INDUCED DAMAGE IN CFRP LAMINATED COMPOSITES WITH SCANNED IMAGE MICROSCOPY

Chiaki Miyasaka<sup>1</sup>, Hideaki Kasano<sup>2</sup> and Bernhard R. Tittmann<sup>1</sup>

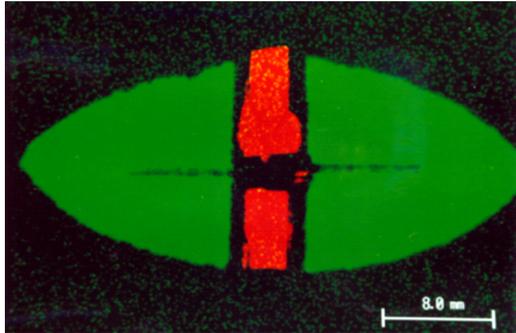
**Fig. 1** Superimposed SAM C-scan images (pulse-wave-mode) showing delaminations at interfaces A and B. Frequency: 30 MHz

The impact damaged specimens were inspected with scanned image microscopy (*i.e.*, Scanning Acoustic Microscopy: SAM, and Scanning Electron Microscopy: SEM). Interface A was between the 6th and 7th plies, and interface B between the 16th and 17 plies, at which major changes in the fiber orientation occurs. The former is located nearer to the front surface (impacted surface) of the specimen and the latter to the back surface (opposite the impacted surface). Figure 1 shows typical delamination patterns of the test specimens impacted by the 5.0mm diameter steel ball at a velocity of 60.0m/s. The damage zones have a characteristic two-lobed shape, long in the preferred directions, *i.e.*, at interface A, extended mainly in the 90-deg ply direction, while at interface B, in the 0-deg ply direction. The damage was confined locally to the areas centered at the impact location, which suggests that the delamination damage was due to the bending-induced stresses. The effects of ply angle on the delamination areas are shown in Figure 2 for the 5.0mm steel balls. The delamination area increases with an increased ply angle, and the increasing rate is remarkably higher at interface B than at interface A. The delamination areas are also related to the size of steel balls. The 10.0mm steel ball exhibited more increase in delamination area than the 5.0mm ball when impacted at the same velocity. If the impact energies are the same for each steel ball, a smaller size impactor with higher velocity tends to produce greater delamination damage. The delamination area ratio at interface A is higher than that at interface B. and it should be noted that the averages for the three specimens were very close to the values calculated from  $V_5/V_{10}$  ( $=2.9$ ) and  $\sqrt{V_5/V_{10}}$  ( $=1.7$ ), respectively.

The damage zones have a characteristic two-lobed shape, long in the  $-$ deg ply direction at interface A (nearer to the impacted surface), while in the 0-deg ply direction at interface B (nearer to the back surface opposite the impacted surface).

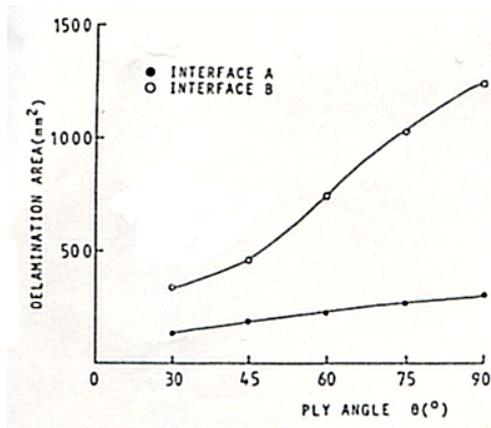
**Fig. 2** Delamination area vs. ply angle

A smaller size impactor with higher velocity tends to produce greater delamination area and more transverse cracks when impacted at the same kinetic energy, while a larger size impactor exhibits more increase in delamination area when impacted at the same velocity.
