EXPERIMENTAL STUDY OF DYNAMIC CRACKING OF PVB LAMINATED GLASS BY HIGH-SPEED PHOTOGRAPHY

In this paper, a new experiment method, say high-speed photography, used for studying dynamic cracking of PVB laminated specimens is introduced. The crack patterns are recorded and analyzed.

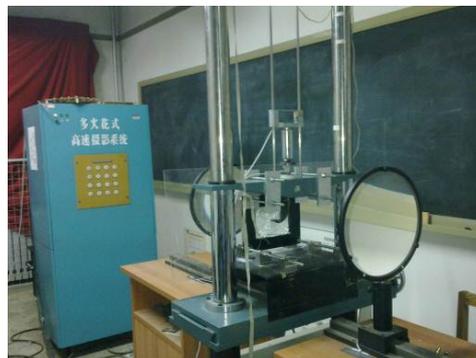
Fig. 2 High-speed photography with multi-sparks

High-speed photography and optical setup. The optical equipment of multi-spark high-speed camera is shown in Fig. 2 and Fig. 3, which includes a 4×4 array-point light source S, two convex lenses F (the objective one and the eyepiece one) with 1.55m focal length and 0.4m diameter and a 4×4 array film camera T. The specimen G is located at the mid-position between the two lenses. In this equipment, the output aperture of the spark gap is small enough to produce a focused point light source. The light rays are converted to be parallel by the objective lenses, and then transmit through the specimen and concentrate onto the film in camera T after the eyepiece. The time intervals between each two neighboring light sources can be adjusted from 1μs to 9999μs, according to the specific crack velocity. Synchronizations of the impact load with the sparks are achieved by means of a time sequence controlled circuit. As the free-falling weight contacts the surface of the impact convertor, which means cracks are going to appear, the circuit connects and thus the first spark is triggered. Afterwards other sparks are also triggered in sequence by the predetermined time intervals. Thus a series of crack images at each data collecting time are recorded by the film in camera.

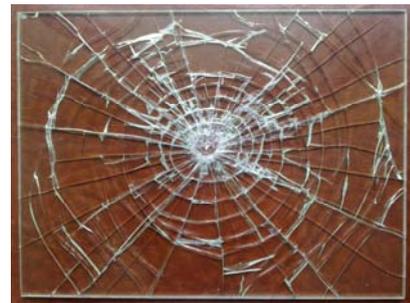
Fig. 5 Specimen after impact

From the comparison between the photographs and the specimen after impact, we find that it is the radial cracks in the front layer of glass that seem thick in photographs, while the ones in the back layer seem slender. Besides, the paths of radial cracks in two layers are nearly overlapped. Therefore it is possibly the refraction of light through the back cracks that make the front ones seem so thick in photographs (as aforementioned, we refer it as "growing").
